Manhole Inspection Summary

Manhole # S51M__039MH

Location Address: **901 s potomac st**

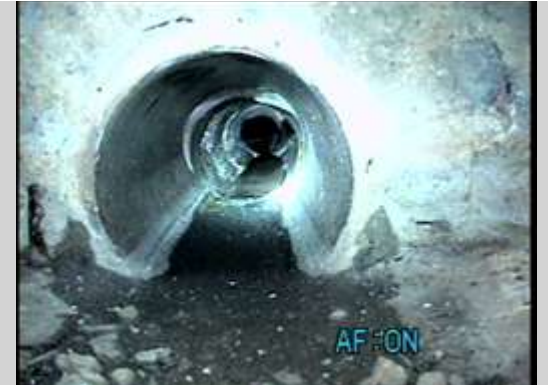
12 O'Clock Outflow

8 in. Circular Gravity Sewer
Pipe Out @ 12 O'Clock

Infiltration: **None** Pipe Seal Cond: **Unknown**
